The Longest Day of the Year for *Over the Moon*

Lessons Learned from a Family Cruise Turned Deadly

"Safety Moments, presented at CCA Stations and Posts"

By Chuck Hawley, San Francisco Station

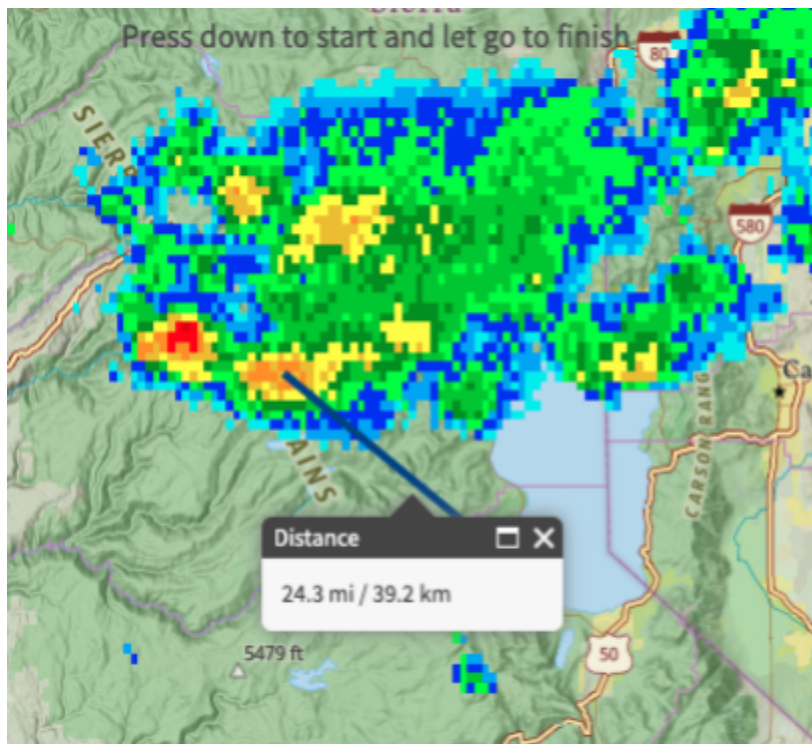
June 21, 1:30pm. The storm was about 25 miles from Emerald Bay.

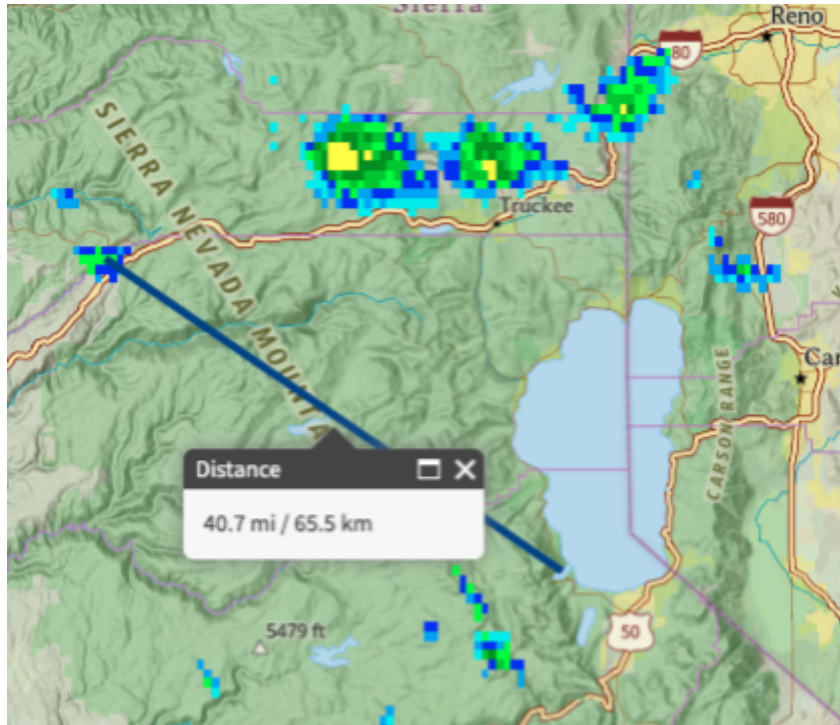
The early stages of the storm at noon on June 21. The SE end of the measurement line is on Emerald Bay, very close to where the accident took place.

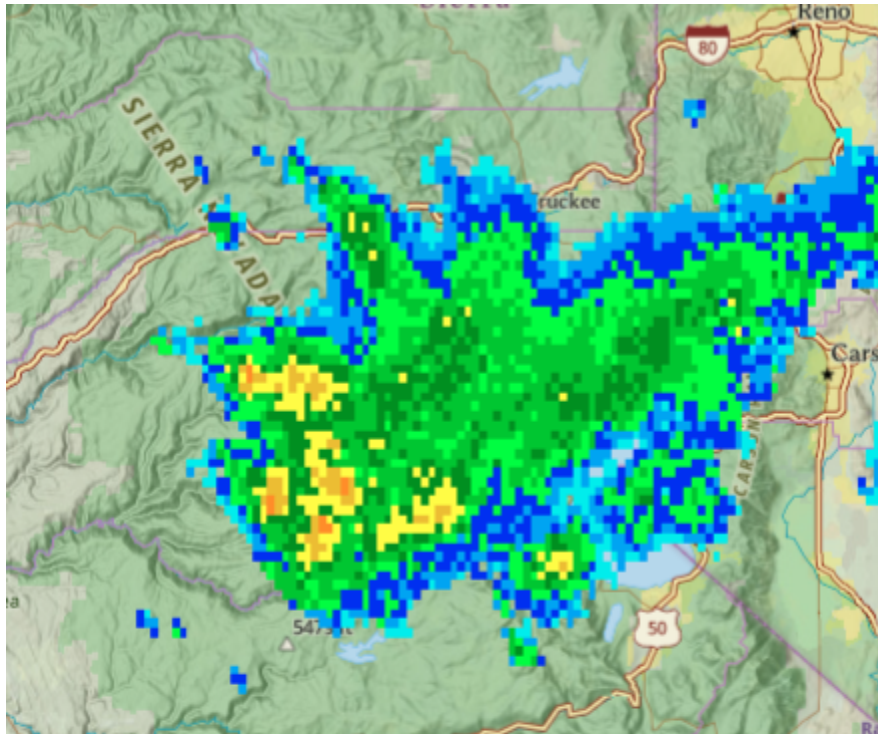
NOAA weather radar at 3:00pm, approximately the time that Over the Moon capsized.

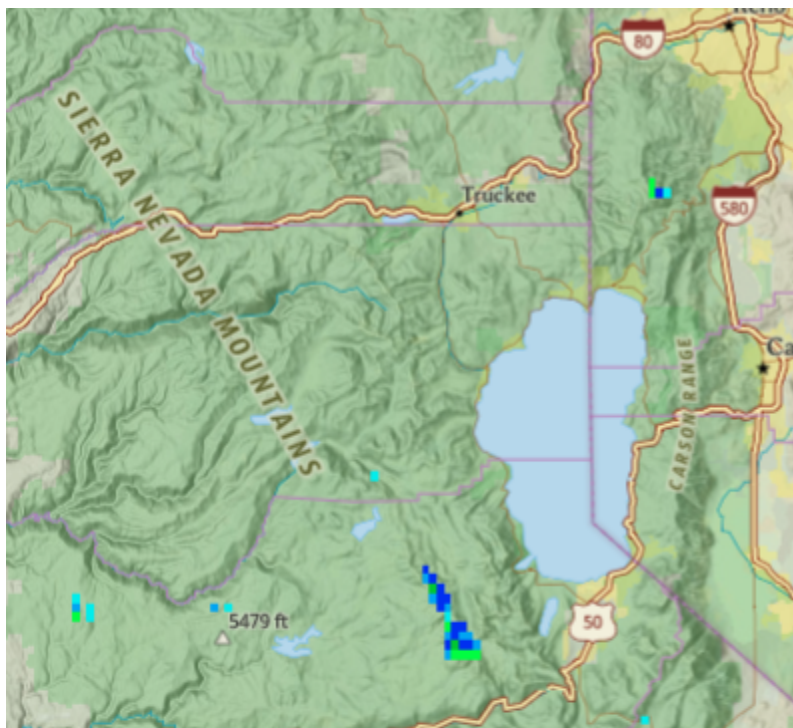
The NOAA radar weather map at 5:00, two hours after the capsizing.

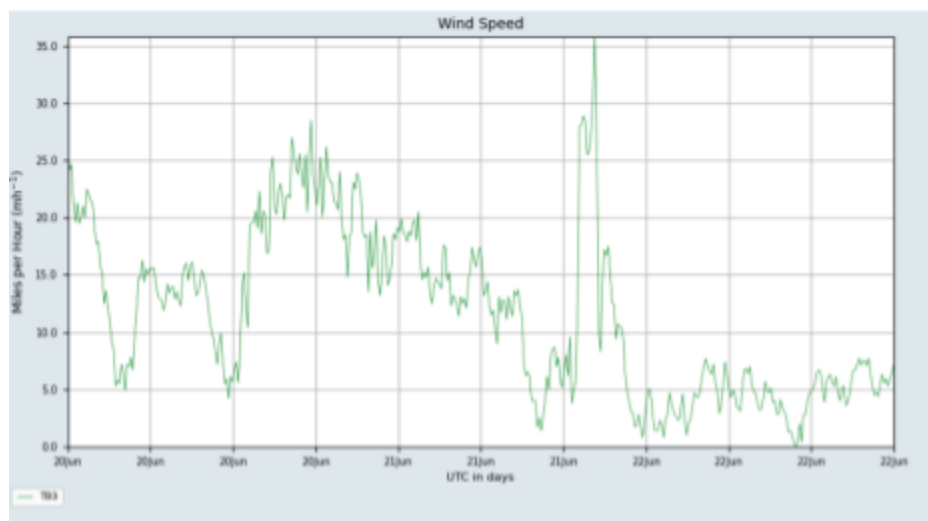
This graph covers three days of time, from 0000Z on June 20 (5:00pm June 19) to 0000Z on June 23 (5:00pm on June 22.) Each horizontal division is 7h20m in width. This shows the intense winds that the area experienced on June 20 all day, and the intense winds that the area experienced around 3:00pm on June 21.

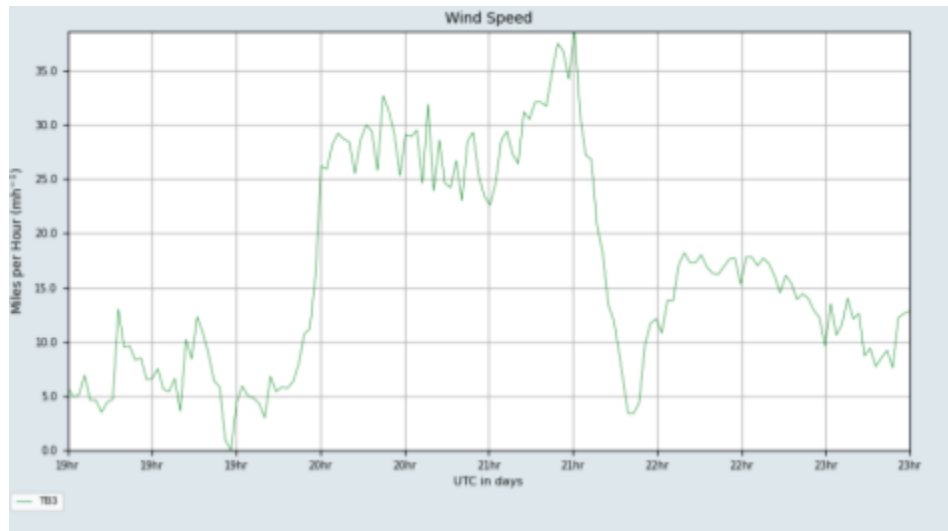
This plot shows the wind velocity from 1900Z (2:00pm) to 2359Z (6:59pm) on June 21. Each horizontal division is 30 minutes. The intense part of the storm occurred between 3:30 and 5:30pm.

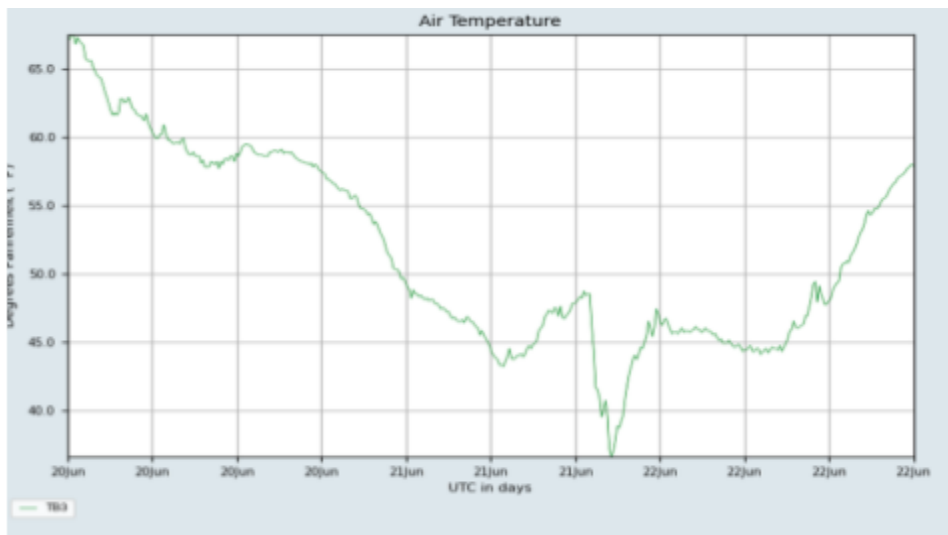
This graph shows the dramatic drop in temperature associated with the storm on June 21, 2025. While the time axis is difficult to measure, the dip in air temperature occurs slightly after the peak wind velocity during the storm.

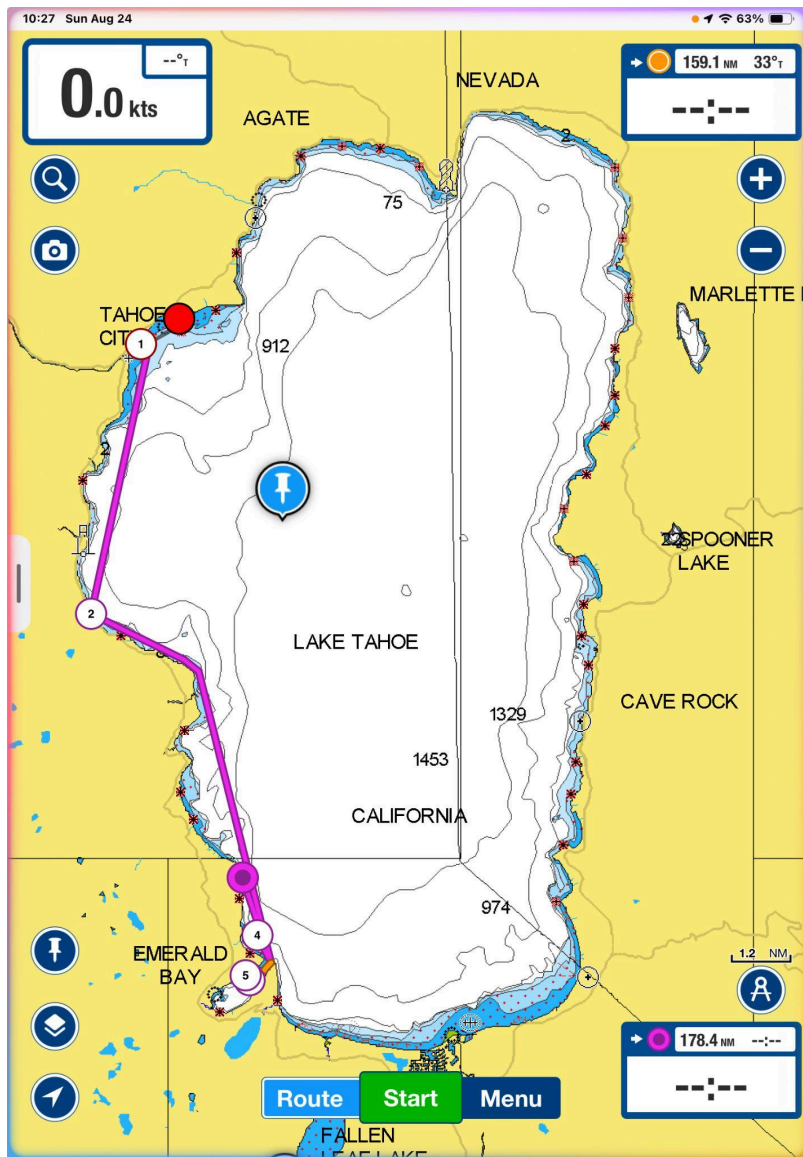
While the actual course of *Over the Moon* on June 21 is not currently known, it may be possible to reconstruct the vessel's track by extracting information from the electronics onboard. The NTSB states that the vessel was launched on a boat ramp in Tahoe City, made two pickups for passengers at marinas along the way, and went as far as Emerald Bay. The additional tracks in Emerald Bay account for the decision to depart, return, and then to depart again.

The pushpin icon is the location of Buoy TB3, which is very close to due north of the accident site, and was a source for most of the meteorological data.

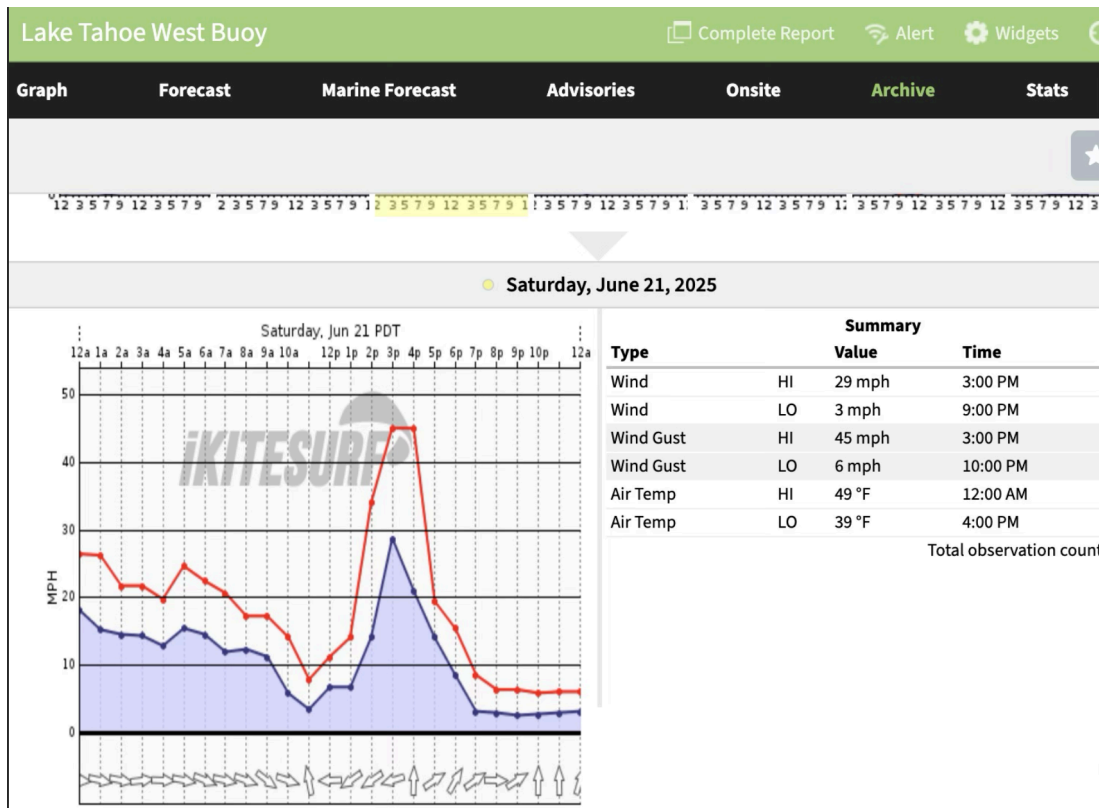
Times in PDT, gusts in red. Wind direction shown at the bottom; note dramatic change in wind direction during storm. Unsure of buoy's exact location.
